Reconnaissance Inspection Report for the Sunnyside Cogeneration Associates

Star Point Refuse Pile - UPDES Permit No. UTG040025

### Water Compliance Inspection Report

Sunnyside Cogen's Star Point Refuse Pile

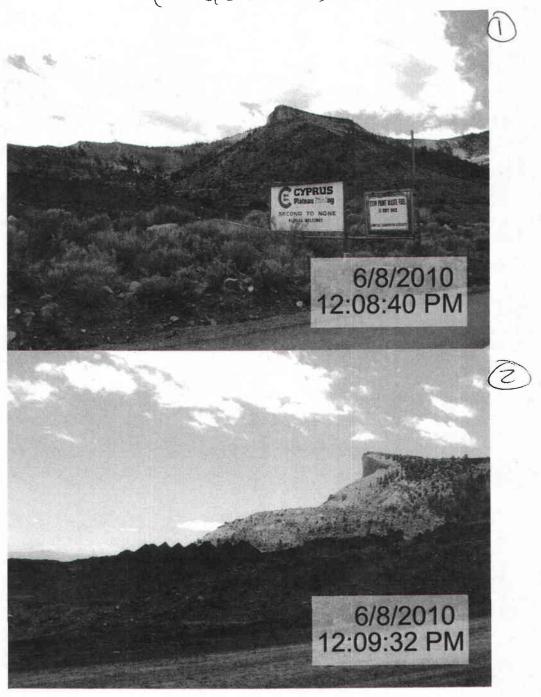
# Sunnyside Coopen's Star Point Refuse Pile (UTG040025)

Photo Log (UTGO40025)						
Photo Number	File Name Description		Date/ Time		Photographer	
		Entrance Gate Near Wattis, UT	6-8-1	0	JS	
(2)	_	Coal Refuse Pile being relocated	6-8-	10	ZL	
3	-	Sedimentation food near coal file	6-8	140	JS	
4	_	Small sed pond along road	6-8	i d	JS	
-	END-					
r.						
				100
